## URGENT MEDICAL DEVICE CORRECTION

GEHC Ref # 36050

RE: **Potential safety risk when using GE Healthcare TruSat Pulse Oximeter with External Power Supply**

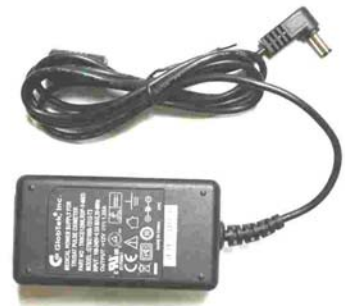
Figure 2, TruSat Oximeter

This action applies to TruSat oximeters with external power supplies sold under the GE or Datex-Ohmeda brand name (figure 2). The reference numbers for the affected TruSat oximeters are listed below. The reference number (REF) can be found printed on a transparent sticker on the bottom of the oximeter.

- 6051-0000-190
- 6051-0000-191
- 6051-0000-192
- 6051-0000-193

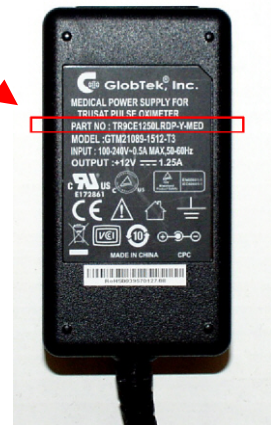
Figure4, External Power Supply device plate

The affected external power supply (figure 3) delivered with the TruSat can be identified with the information provided below (figure 4).

GlobTek, Inc.  
MEDICAL POWER SUPPLY FOR TRUSAT PULSE OXIMETER  
**PART NO: TR9CE1250LRDP-Y-MED**

GE will replace all affected external power supplies with a new power supply. The replacement power supply is designed to meet the requirements for medical devices.
